TECHNICAL REPORT NO. 246

The Installation of a new Transmission Monitor in Izaña in 2004 November

Steven J. Hale and Brek A. Miller

2005 January 26

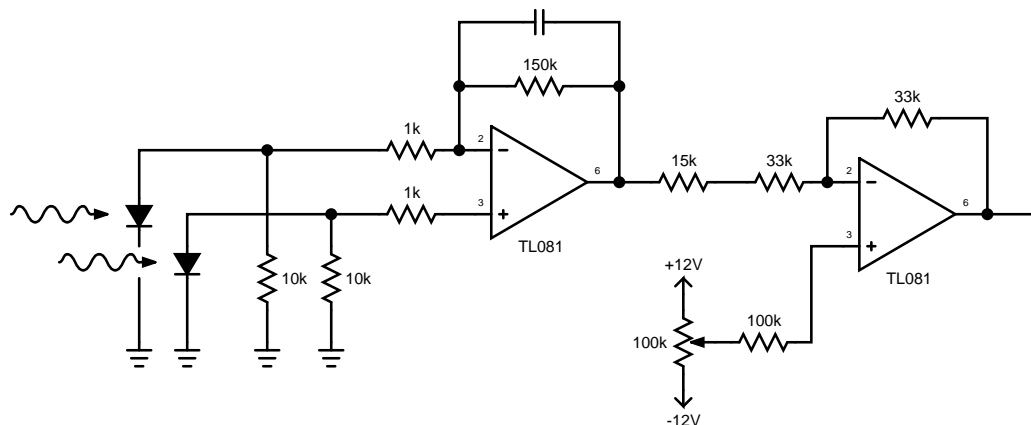
Figure 1: A partial schematic drawing of the autoguider differencer.

While we were examining the autoguider differencer, we made a note of part of the circuit inside. It is built on a piece of Veroboard. We did not remove the Veroboard so we could not make a complete circuit drawing, but we were able to learn that the photodiodes are being used in voltage mode. The partial circuit is shown in Figure 1.
